Manhole Inspection Summary

Manhole # S15KK_008MH

Insp Date: **2/24/09 1:52 PM**

Location Address: **2100 BRADDISH AVE**

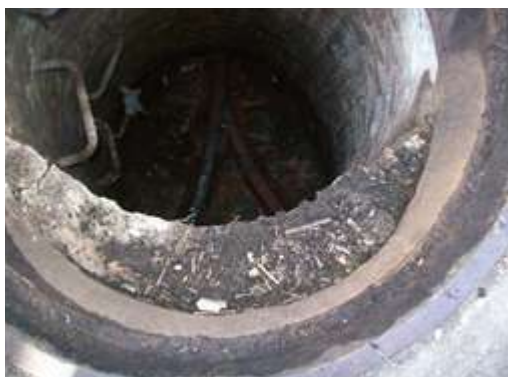
Defect 1

Offset: **4** (in.)

FRAME OFFSET

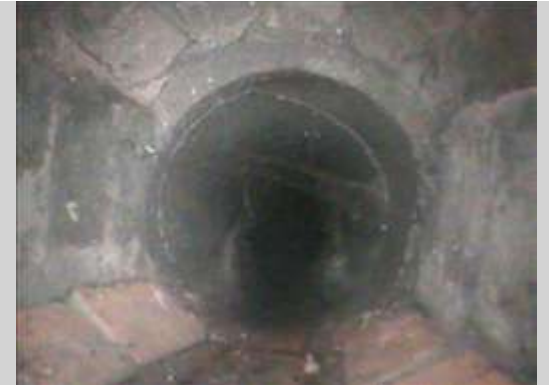
12 O'Clock Outflow

8 in. Circular Gravity Sewer
Pipe Out @ 12 O'Clock

Pipe Material: **Clay** ☐ Pipe Lined

Invert Depth: **9.00** (ft.) Flow Characteristics: **Slow**

Deposits: ☒ None ☐ Mud ☐ Sludge ☐ Debris ☐ Grease

Infiltration: **None** Pipe Seal Cond: **Sound**

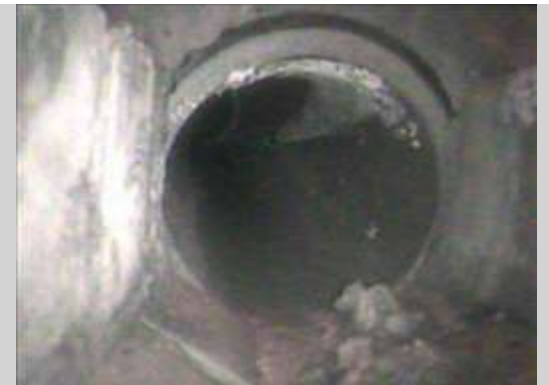
5 O'Clock Inflow

6 in. Circular Gravity Sewer
Pipe In @ 5 O'Clock

Pipe Material: **Clay** ☐ Pipe Lined

Invert Depth: **8.95** (ft.) Flow Characteristics: **Slow**

Deposits: ☒ None ☐ Mud ☐ Sludge ☐ Debris ☐ Grease

Infiltration: **None** Pipe Seal Cond: **Sound**

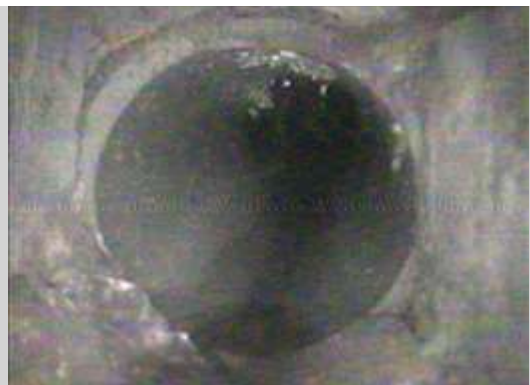
7 O'Clock Inflow

6 in. Circular Gravity Sewer
Pipe In @ 7 O'Clock

Pipe Material: **Clay** ☐ Pipe Lined

Invert Depth: **8.92** (ft.) Flow Characteristics: **Slow**

Deposits: ☒ None ☐ Mud ☐ Sludge ☐ Debris ☐ Grease

Infiltration: **None**

Pipe Seal Cond: **Sound**
